The location of the church is TF 80479 35230 \pm 7 m (measured at the centre of the east wall).

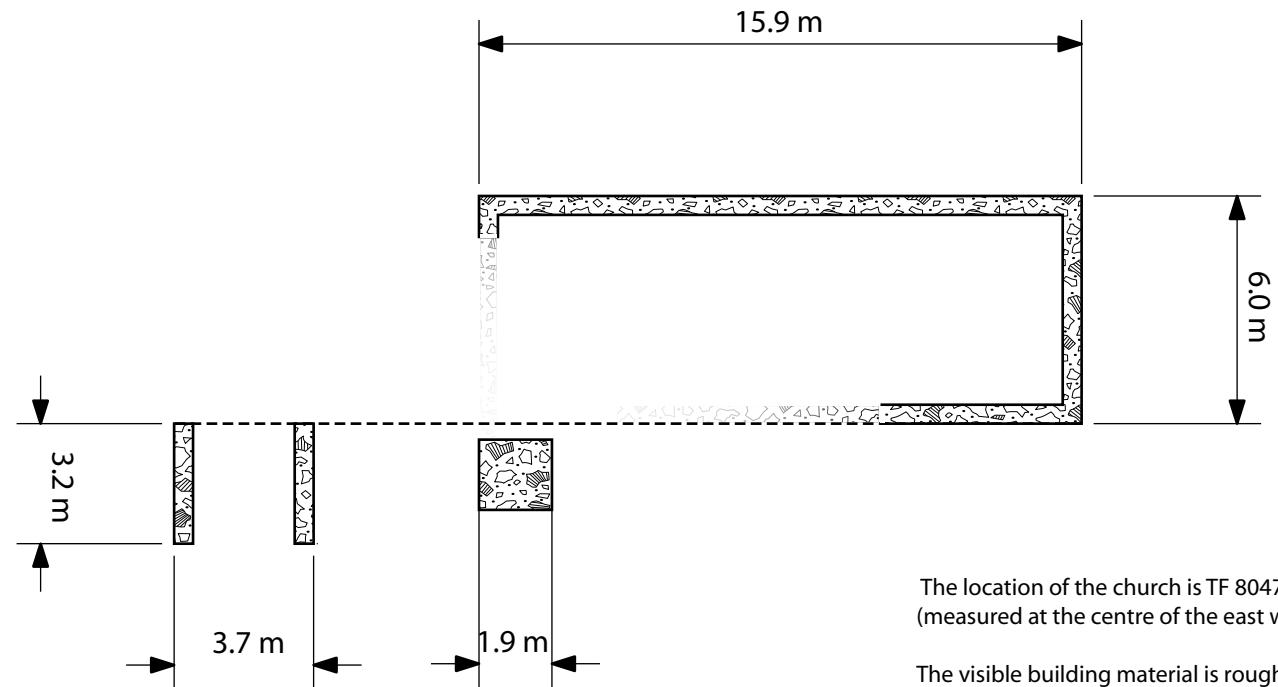
The visible building material is rough flint and lime mortar. The area is scattered with decayed mortar and fragments of flint.

The walls are nowhere higher than 30 cm, and in most places they are at ground level.

The floor of the main body of the church is below ground level, perhaps as a result of C18–19 excavations.
